# Laser Scanning an Ice Rink Mechanical Room for Facility Management

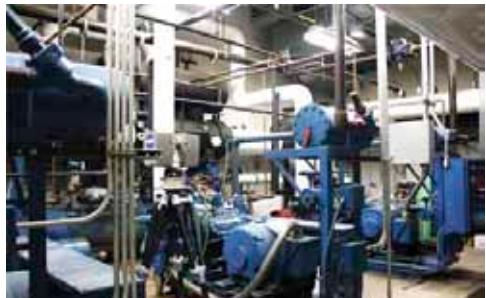
The mechanical room to be refitted was approximately 30 x 50 ft and full of machines and equipment that operated the ice arena. Everything needed to be modeled to avoid creating interferences between the room's contents when the new refrigeration unit and the associated piping were installed. The GKS engineer used the FARO® Laser Scanner Photon to perform the scan. Since the room was crowded with equipment, six setups were required to capture all the features present with an unobstructed field of view.

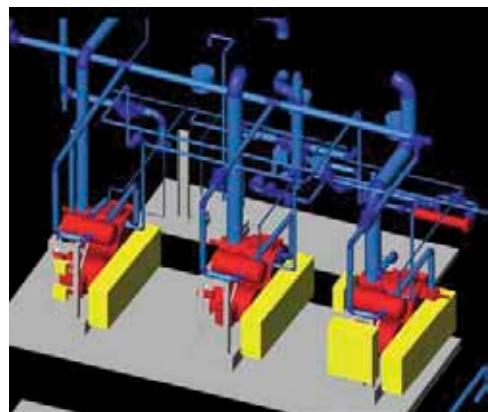
The entire scanning process took approximately 1 hour to complete, collecting over 250 million data points. The alternate way of acquiring this type of detailed dimensional data would have been to measure everything manually with tape measures and rulers, and to write down each dimension on a two-dimensional hard-copy drawing. This method would have taken at least 3 weeks to complete, and would have cost at least double the amount spent on laser scanning. The results would not have been as accurate or complete, and very prone to human error in measuring and recording the numbers. Also, the z-axis (vertical) measurements would have had to have been recorded on the two-dimensional drawing.

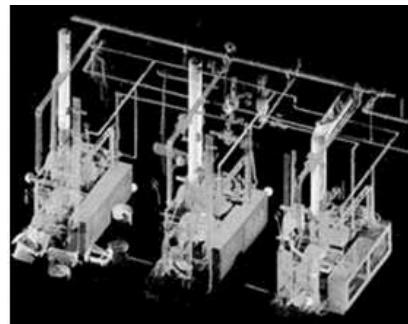
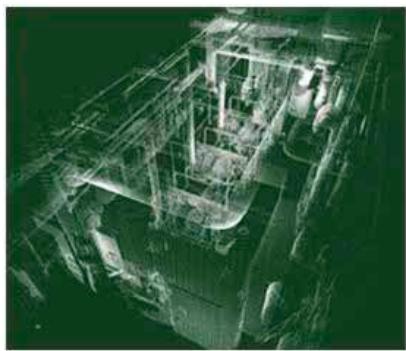
The scan data of the room and the equipment was collected in an hour and provided accuracies of  $\pm .08"$ ; modeling took place in AutoCAD in about 3 days with an accuracy of  $\pm .5"$ . The precise model of the room and its contents allowed the consulting engineers to plan the tear-out in stages, with temporary lines facilitating the switchover. They accomplished all the updates on the plumbing and electric systems before having to go "offline" while replacing the cooling unit.

Because the model was so accurate, the retrofits went in without a hitch. The engineering firm was able to use the scan data layers to separate their work into phases. This made it easy to see the existing configuration, determine what would remain after the installation, what would be removed, and where the new equipment would fit. The new geoexchange system was very complicated and high-tech, so having the thorough accurate map of the space was a tremendous advantage. Downtime at the rink was minimal, just 8 hours while the new system was installed and the pipes were hooked up. Once again the speed of the refurbishing process made possible with laser scanning by GKS
